## GEO-FOUNDATIONS Contractors Inc.

### CN Fairchild Creek

Date: 2001  
Technology: Soil Nailing

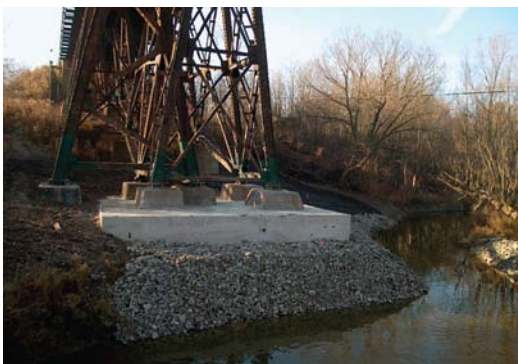
*New ring beam encapsulating rehabilitated pier grouping*

A new, self-supporting, anchored ring beam structure was built to encapsulate and permanently stabilize the subject group of foundations. Micropiles, drilled using eccentric duplex and embedded 11 metres deep, formed a portion of the new reinforced concrete ring beam's foundation, while multiple raked soil anchors were drilled 20 metres deep into the slope to provide embedment into strata beyond known slip-surface limits.

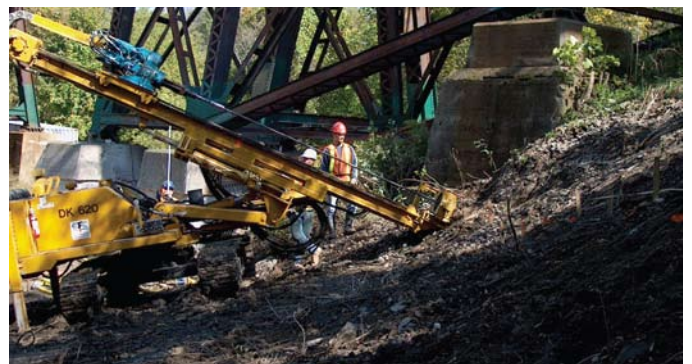
*Soil nail installation at south creek bank*

Soil nailing of the south bank consisted of four rows of 15-metre long nails on 1-metre lateral spacing to treat over 2200m<sup>2</sup> of slope face. A coated multi-strand polyester geogrid was installed in tension over the ground surface and anchored to the soil nail heads before being treated with topsoil and hydroseeding. Rip rap was installed over both banks of the creek, through the reconstruction area, to 2 metres above nominal water level.
