GEO-FOUNDATIONS Contractors Inc.

CN Sunfish Pond

Date: 2006
Technology: Soil Nailing

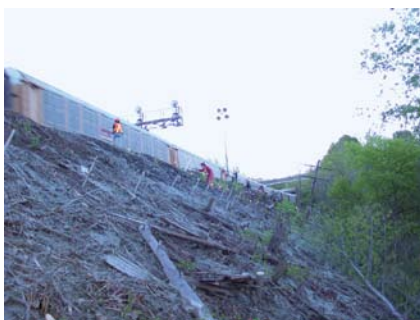
Sunfish Pond: south slope of rail embankment with new soil nails

In total, 405 grout-flushed, 40 mm hollow bar soil nails, each embedded 12 metres, were installed. After soil nail installation was complete, a separate mounting bracket and vertical mast arrangement were fabricated to allow installation of inclinometer casings, whose locations were typically 5 metres downslope of the crest in locations otherwise inaccessible to any drill rig.

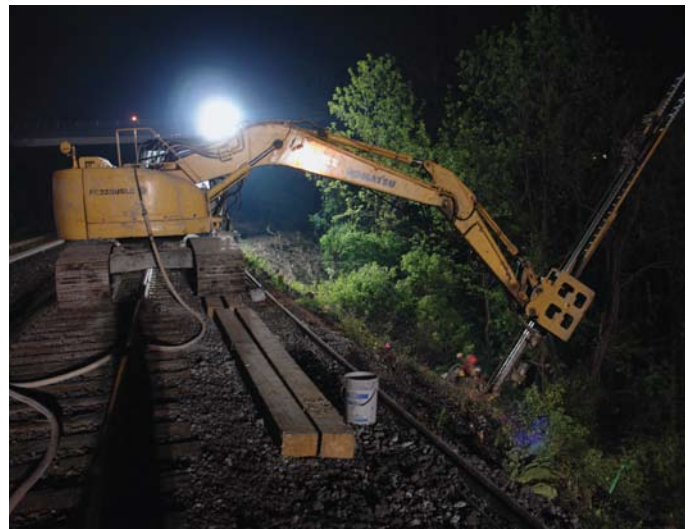
Sunfish Pond: zero-clearance rig installing soil nails during night shift

A reduced tail swing hydraulic excavator, with a long reach boom, was outfitted with a custom-built drill mast to achieve the reach and angle of drilling required. The mast and its mounting bracket were fabricated in Geo-Foundations' shop along with quick-connect plumbing mated to the excavator's controls.

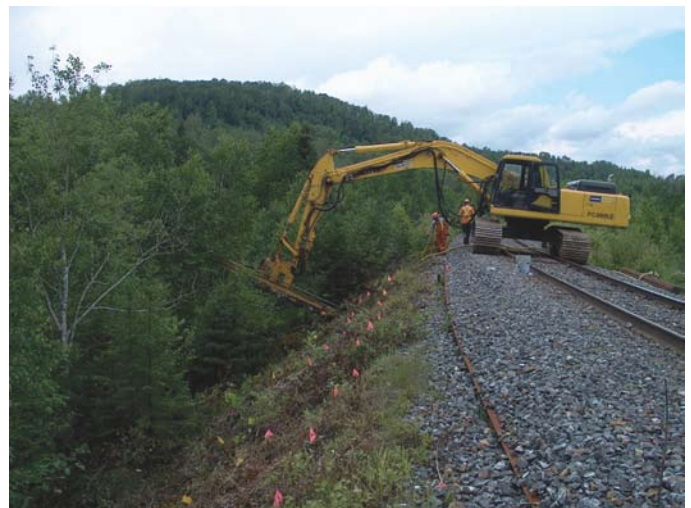
Soil nailing at Latuque, Quebec

Soon after the completion of grout-flushed soil nail installation at the Sunfish Pond site, Geo-Foundations was contracted by CN to complete a similar slope stabilization project on a single-track embankment north of Latuque, Quebec. For the Latuque site, where a reduced tail swing unit was

not required, but where the soil nails had to be drilled farther (9 metres) down the slope, a larger excavator was used. At Latuque, 128 grout-flushed, 9-metre deep, 40 mm hollow bar soil nails were installed.
