GEO-FOUNDATIONS
Contractors Inc.

Meno-Ya-Win Health Centre

Date: 2008
Technology: Micropiles

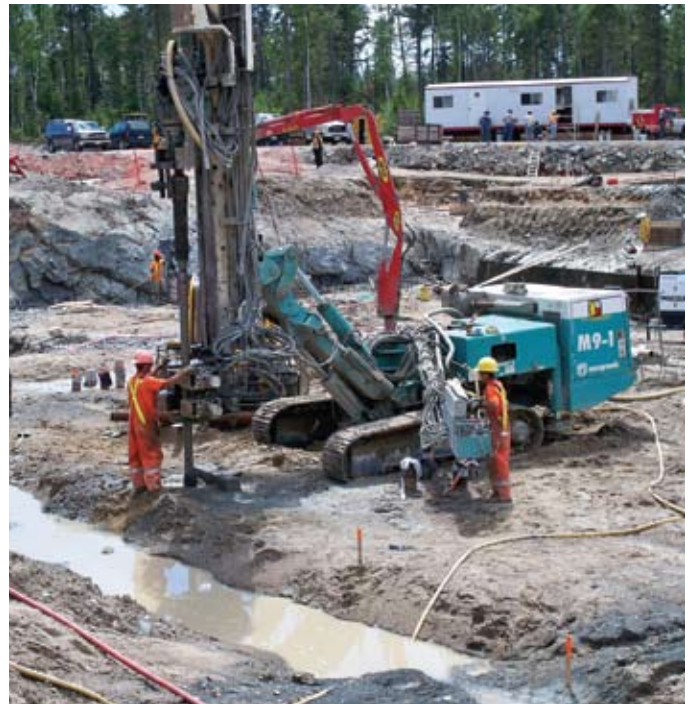
Drilling of piles at The Gathering Area — note bedrock outcropping in near background

Drilling of the piles was completed using a single-head, shoeless, percussive, rotary-duplex drilling process employing NUMA T150 Superjaws tooling. Immediately after being tremie grouted, each pile was pressure grouted to force grout into the annulus between the outside pipe wall and the inside of the rock socket. A premium grout blend, complete with superplasticizer and shrinkage compensating agents, was used.

The principle challenge to the successful installation of piles at this site was the varying and erratic elevation of the top of bedrock. In many instances, depth to bedrock was found to differ as much as 6 metres within a lateral distance of just 2 metres. Added to this difficulty was the hardness of the bedrock which consumed several drill bits over the course of installing the production piles and load test tie-down anchors.

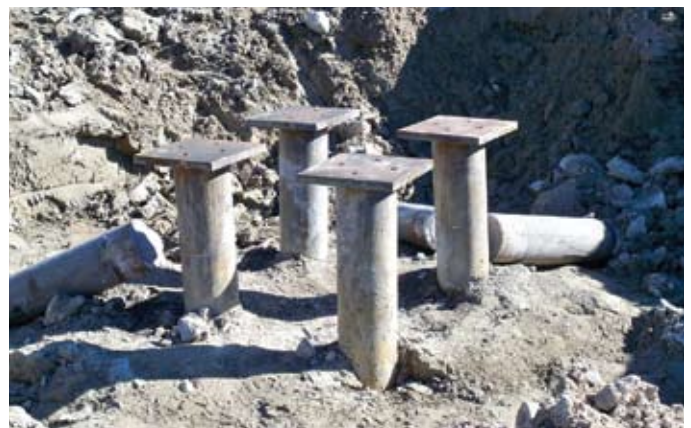
Piles cut down and awaiting welding of top plates at a typical PC-5 Pile Cap
